USAAEFA PROJECT NO. 85-03

AIRWORTHINESS AND FLIGHT CHARACTERISTICS OF THE JOH - 58C (OH-58X SURROGATE) HELICOPTER

FEBRUARY 1986

FINAL REPORT

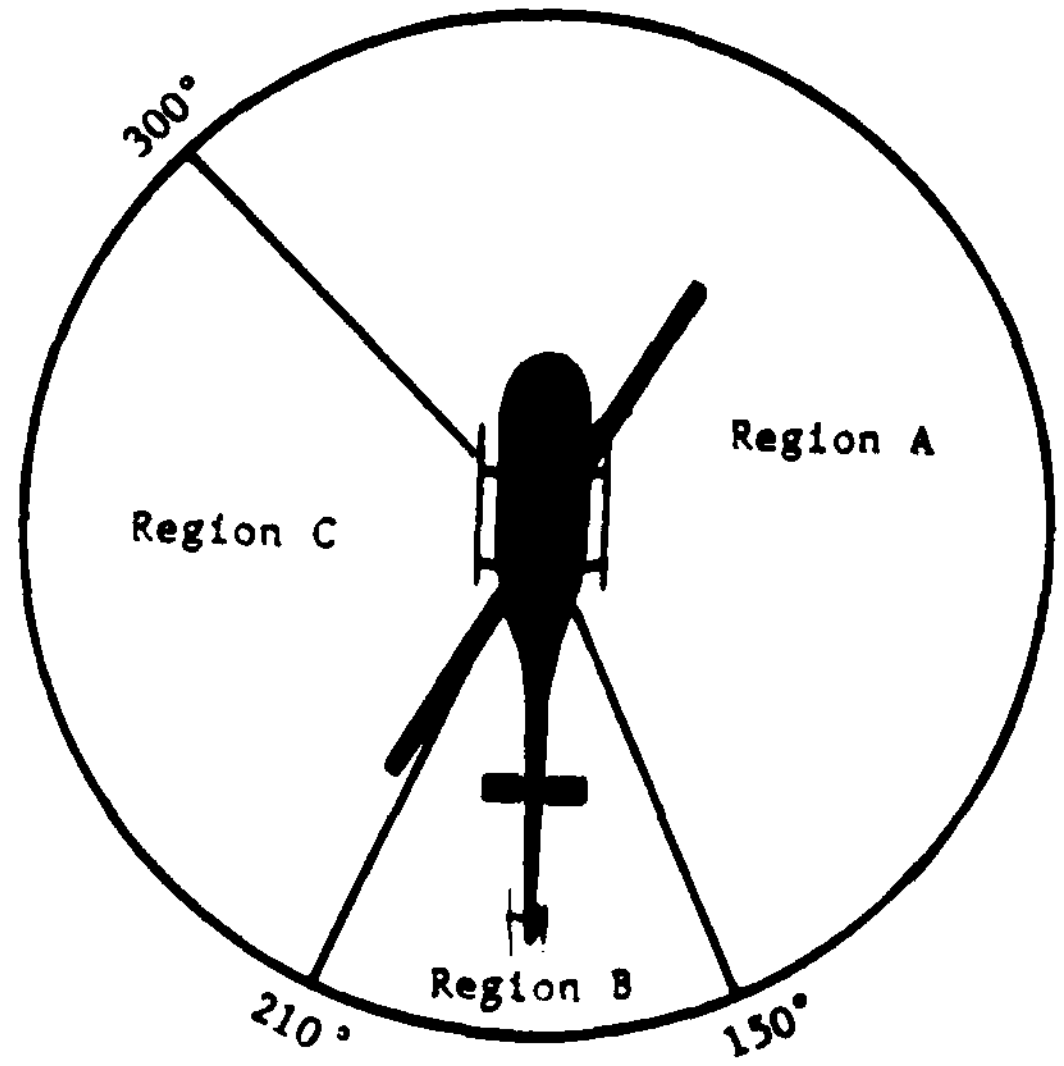
Figure A. Low Speed Flight Regions

21. Low speed flight characteristics were evaluated to determine the effects on handling qualities due to the installation of the SAS and the improved tail rotor. The low speed flight testing was conducted by stabilizing in formation with a ground pace vehicle at a skid height of approximately 10 feet at relative azimuths (measured clockwise from the nose of the aircraft) from 0 degrees to 360 degrees in 30 degree increments. The low speed flight characteristics for this aircraft can be discussed by reference to one of three regions (fig. A): 300 degrees clockwise to 150 degrees (region A), 150 degrees clockwise to 210 degrees (region B) and 210 degrees clockwise to 300 degrees (region C).

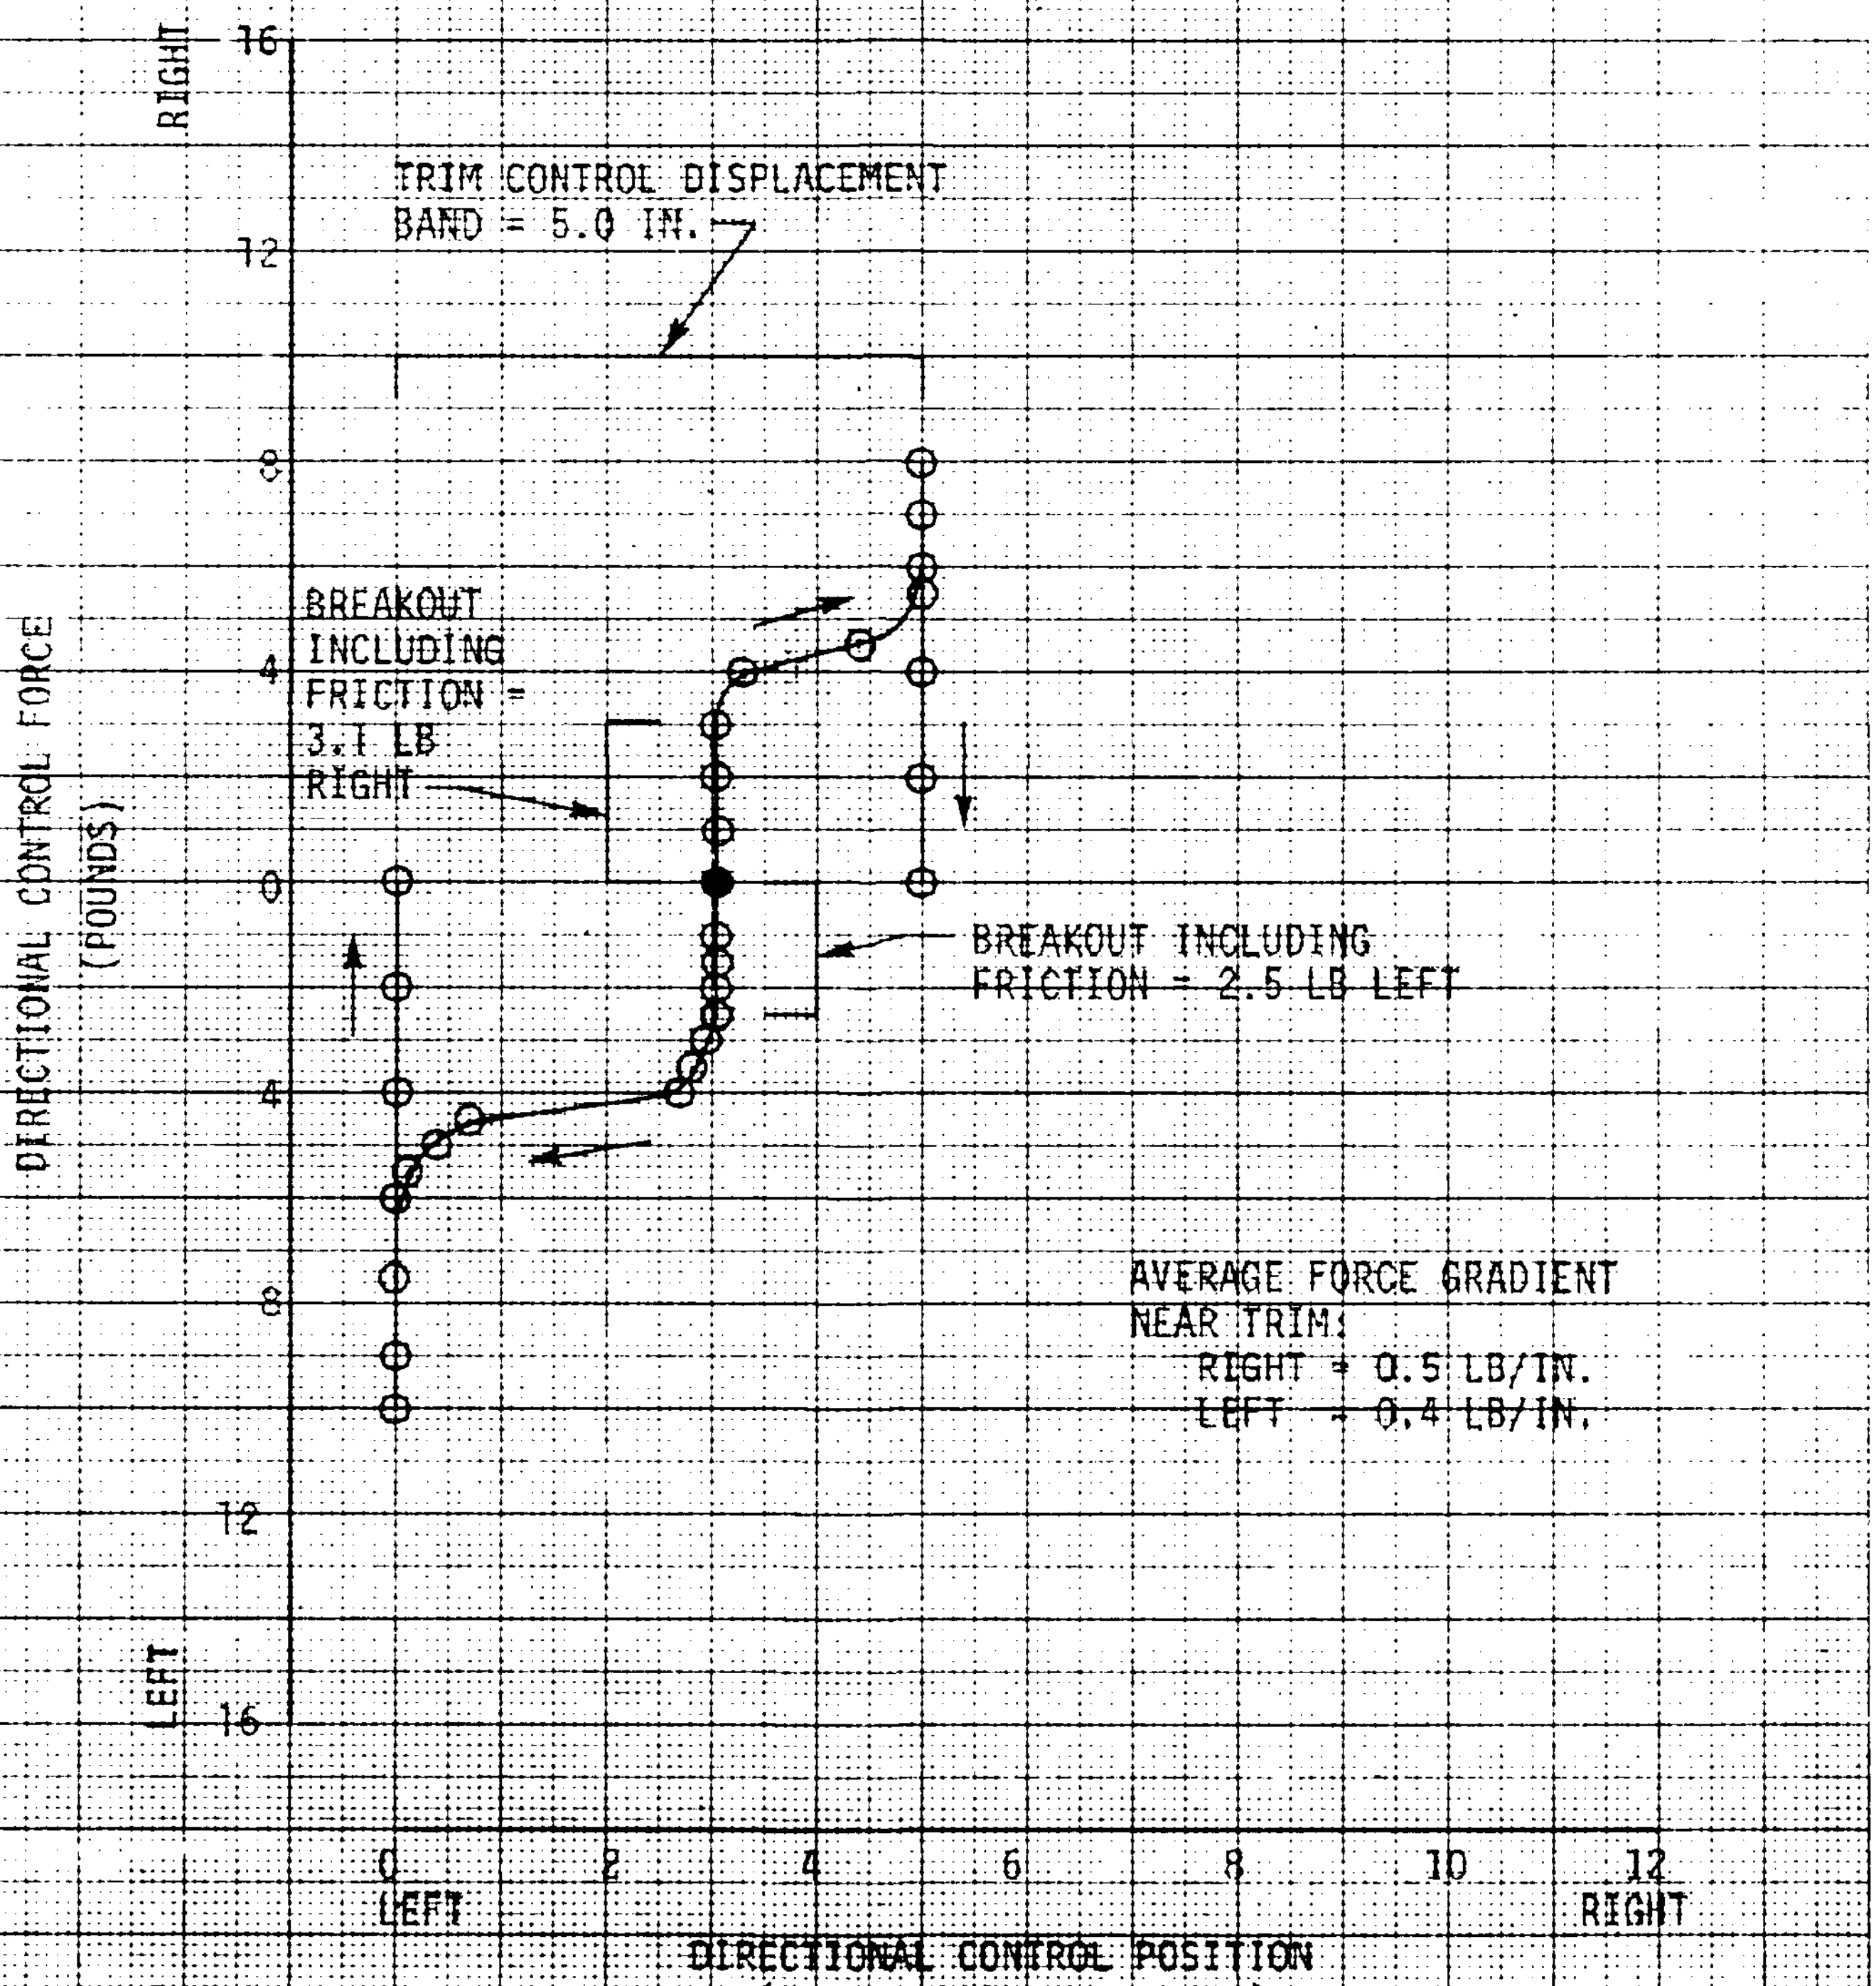
FIGURE 5
CONTROL POSITIONS IN TRIMMED FORWARD FLIGHT
JOH-58C USA S/N 70-15349

11. Control positions in trimmed forward flight were evaluated at the conditions listed in table 1. Test results are presented in figures 5 through 8, appendix E. The variation of longitudinal control position was conventional in that increased forward cyclic was required to trim at increased airspeed. The lateral and directional control displacements required with increased airspeed were minimal and control margins at all conditions tested were adequate. The level flight control positions in trimmed forward flight of the JOH-58C in the modified clean configuration were similar to the standard OH-58C helicopter (ref 8, app A) and are satisfactory.

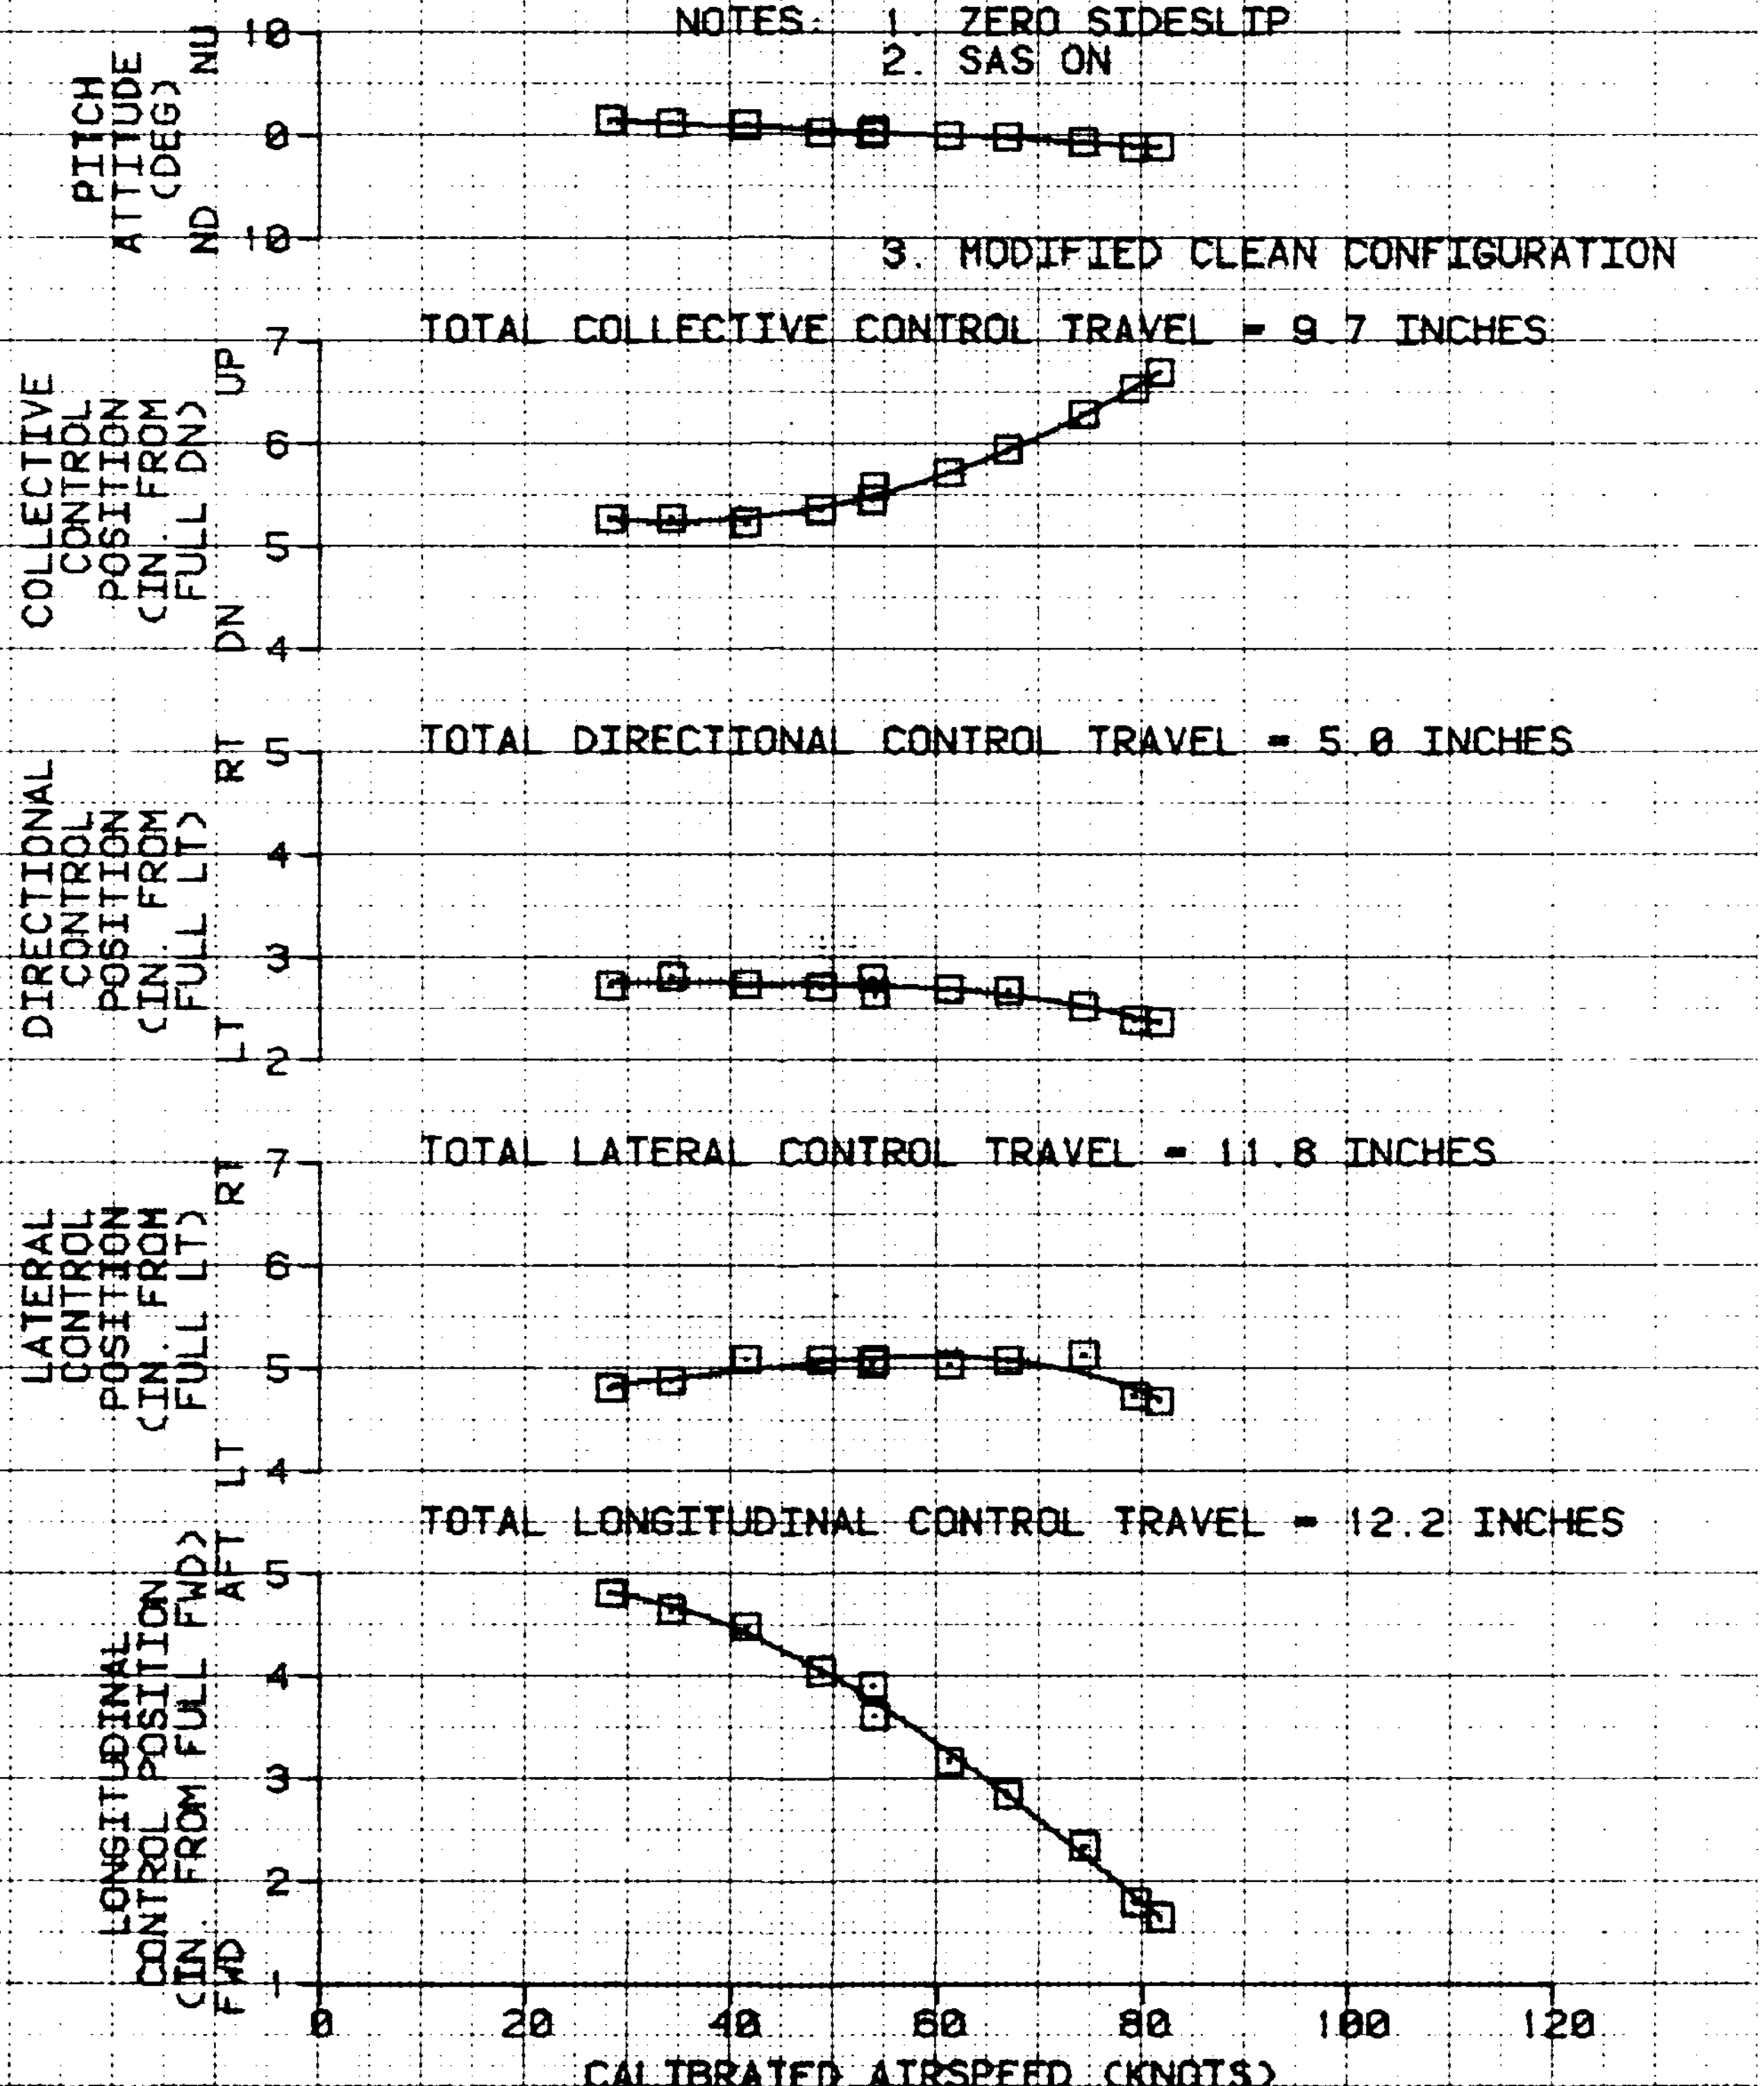
FIGURE 9

12. The static longitudinal stability characteristics of the JOH-58C were evaluated in level flight at the conditions listed in table 1. Test results are presented in figures 9 and 10, appendix E. The static longitudinal stability was nearly neutral at both conditions tested. Although the position cues for an off trim airspeed condition were slight, it was easy to maintain trim airspeed (HQRS 3). Even though the longitudinal control gradients of the JOH-58C failed to meet the requirements of MIL-H-8501A, paragraph 3.2.10, in that there was no positive control position stability near trim cruise airspeed, the static longitudinal stability of the JOH-58C is satisfactory.

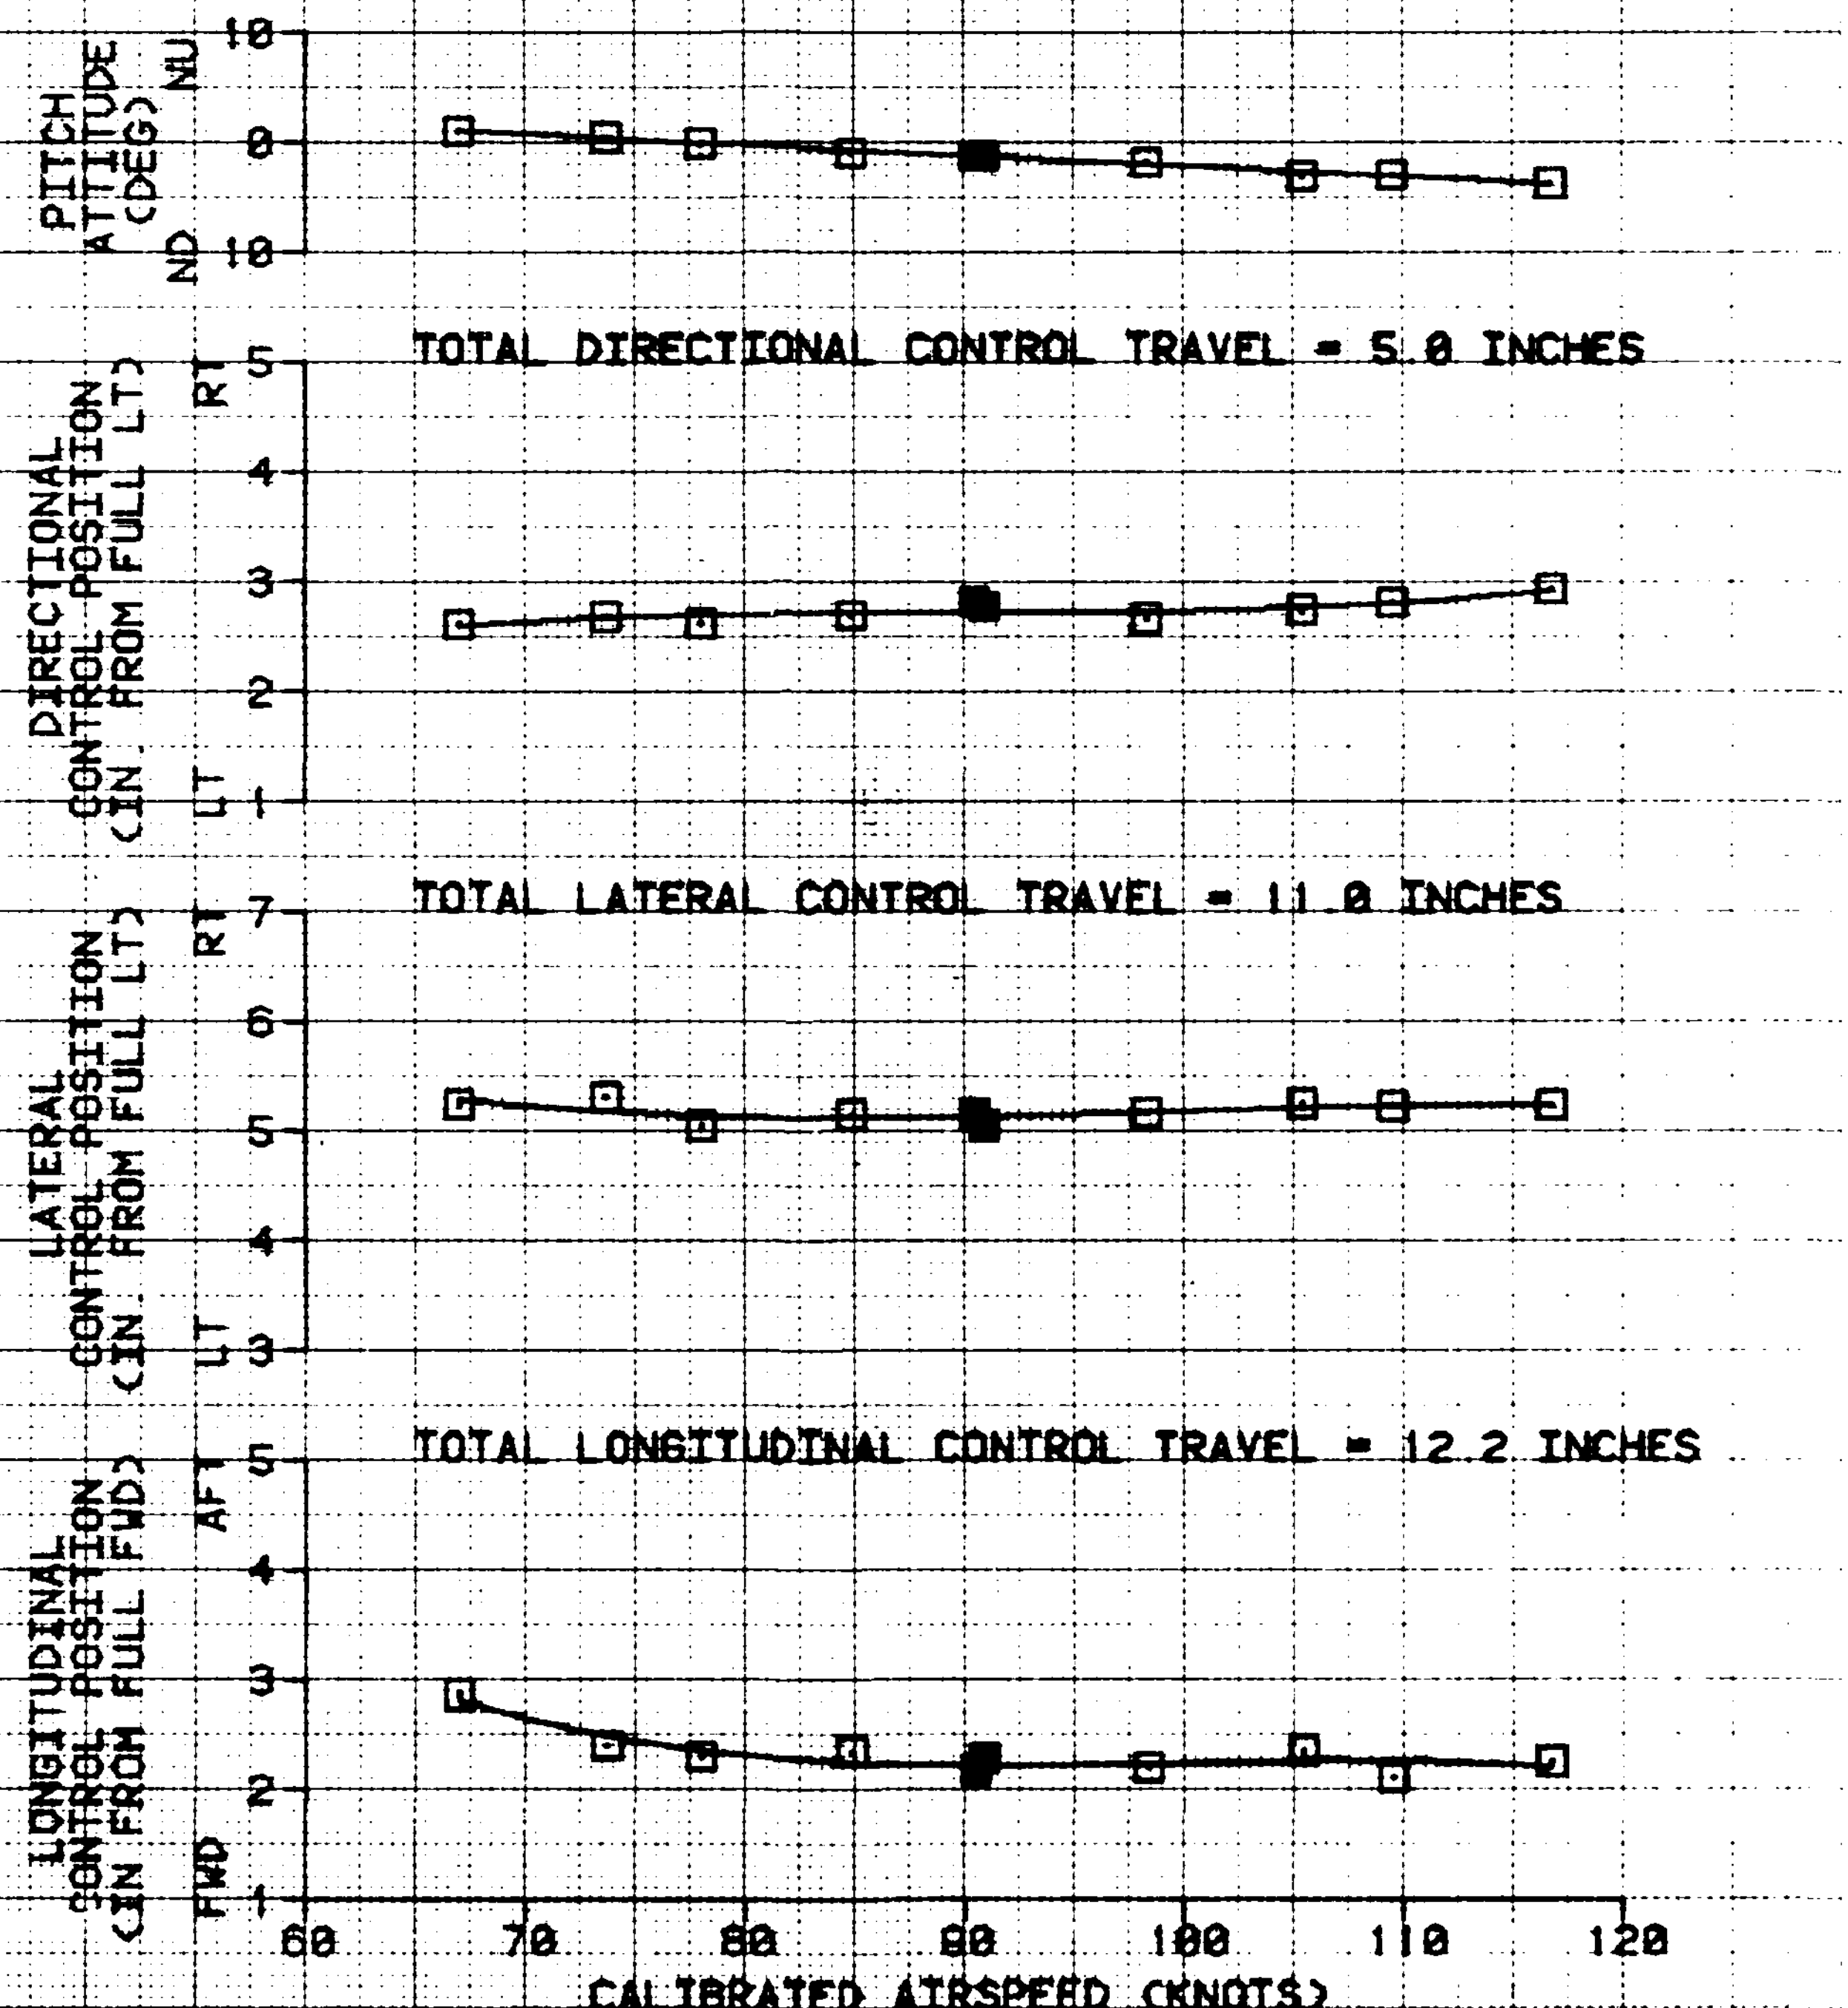
FIGURE 11

13. The static lateral-directional stability characteristics of the JOH-58C were evaluated in level flight at the conditions listed in table 1. Test results are presented in figures 11 and 12, appendix E. Static directional stability, as indicated by the variation of directional control position with sideslip, was positive at all test conditions. Dihedral effect, as indicated by the variation of lateral control position with sideslip, was positive for all conditions tested. Side force characteristics, as indicated by the variation of roll attitude with sideslip, were positive for all conditions tested. The gradient at the lower airspeed was slightly shallower than in the standard OH-58C (ref 8, app A). The pilot had adequate cues of an out-of-trim condition and was able to correct it easily. The static lateral-directional stability characteristics of the JOH-58C are satisfactory.

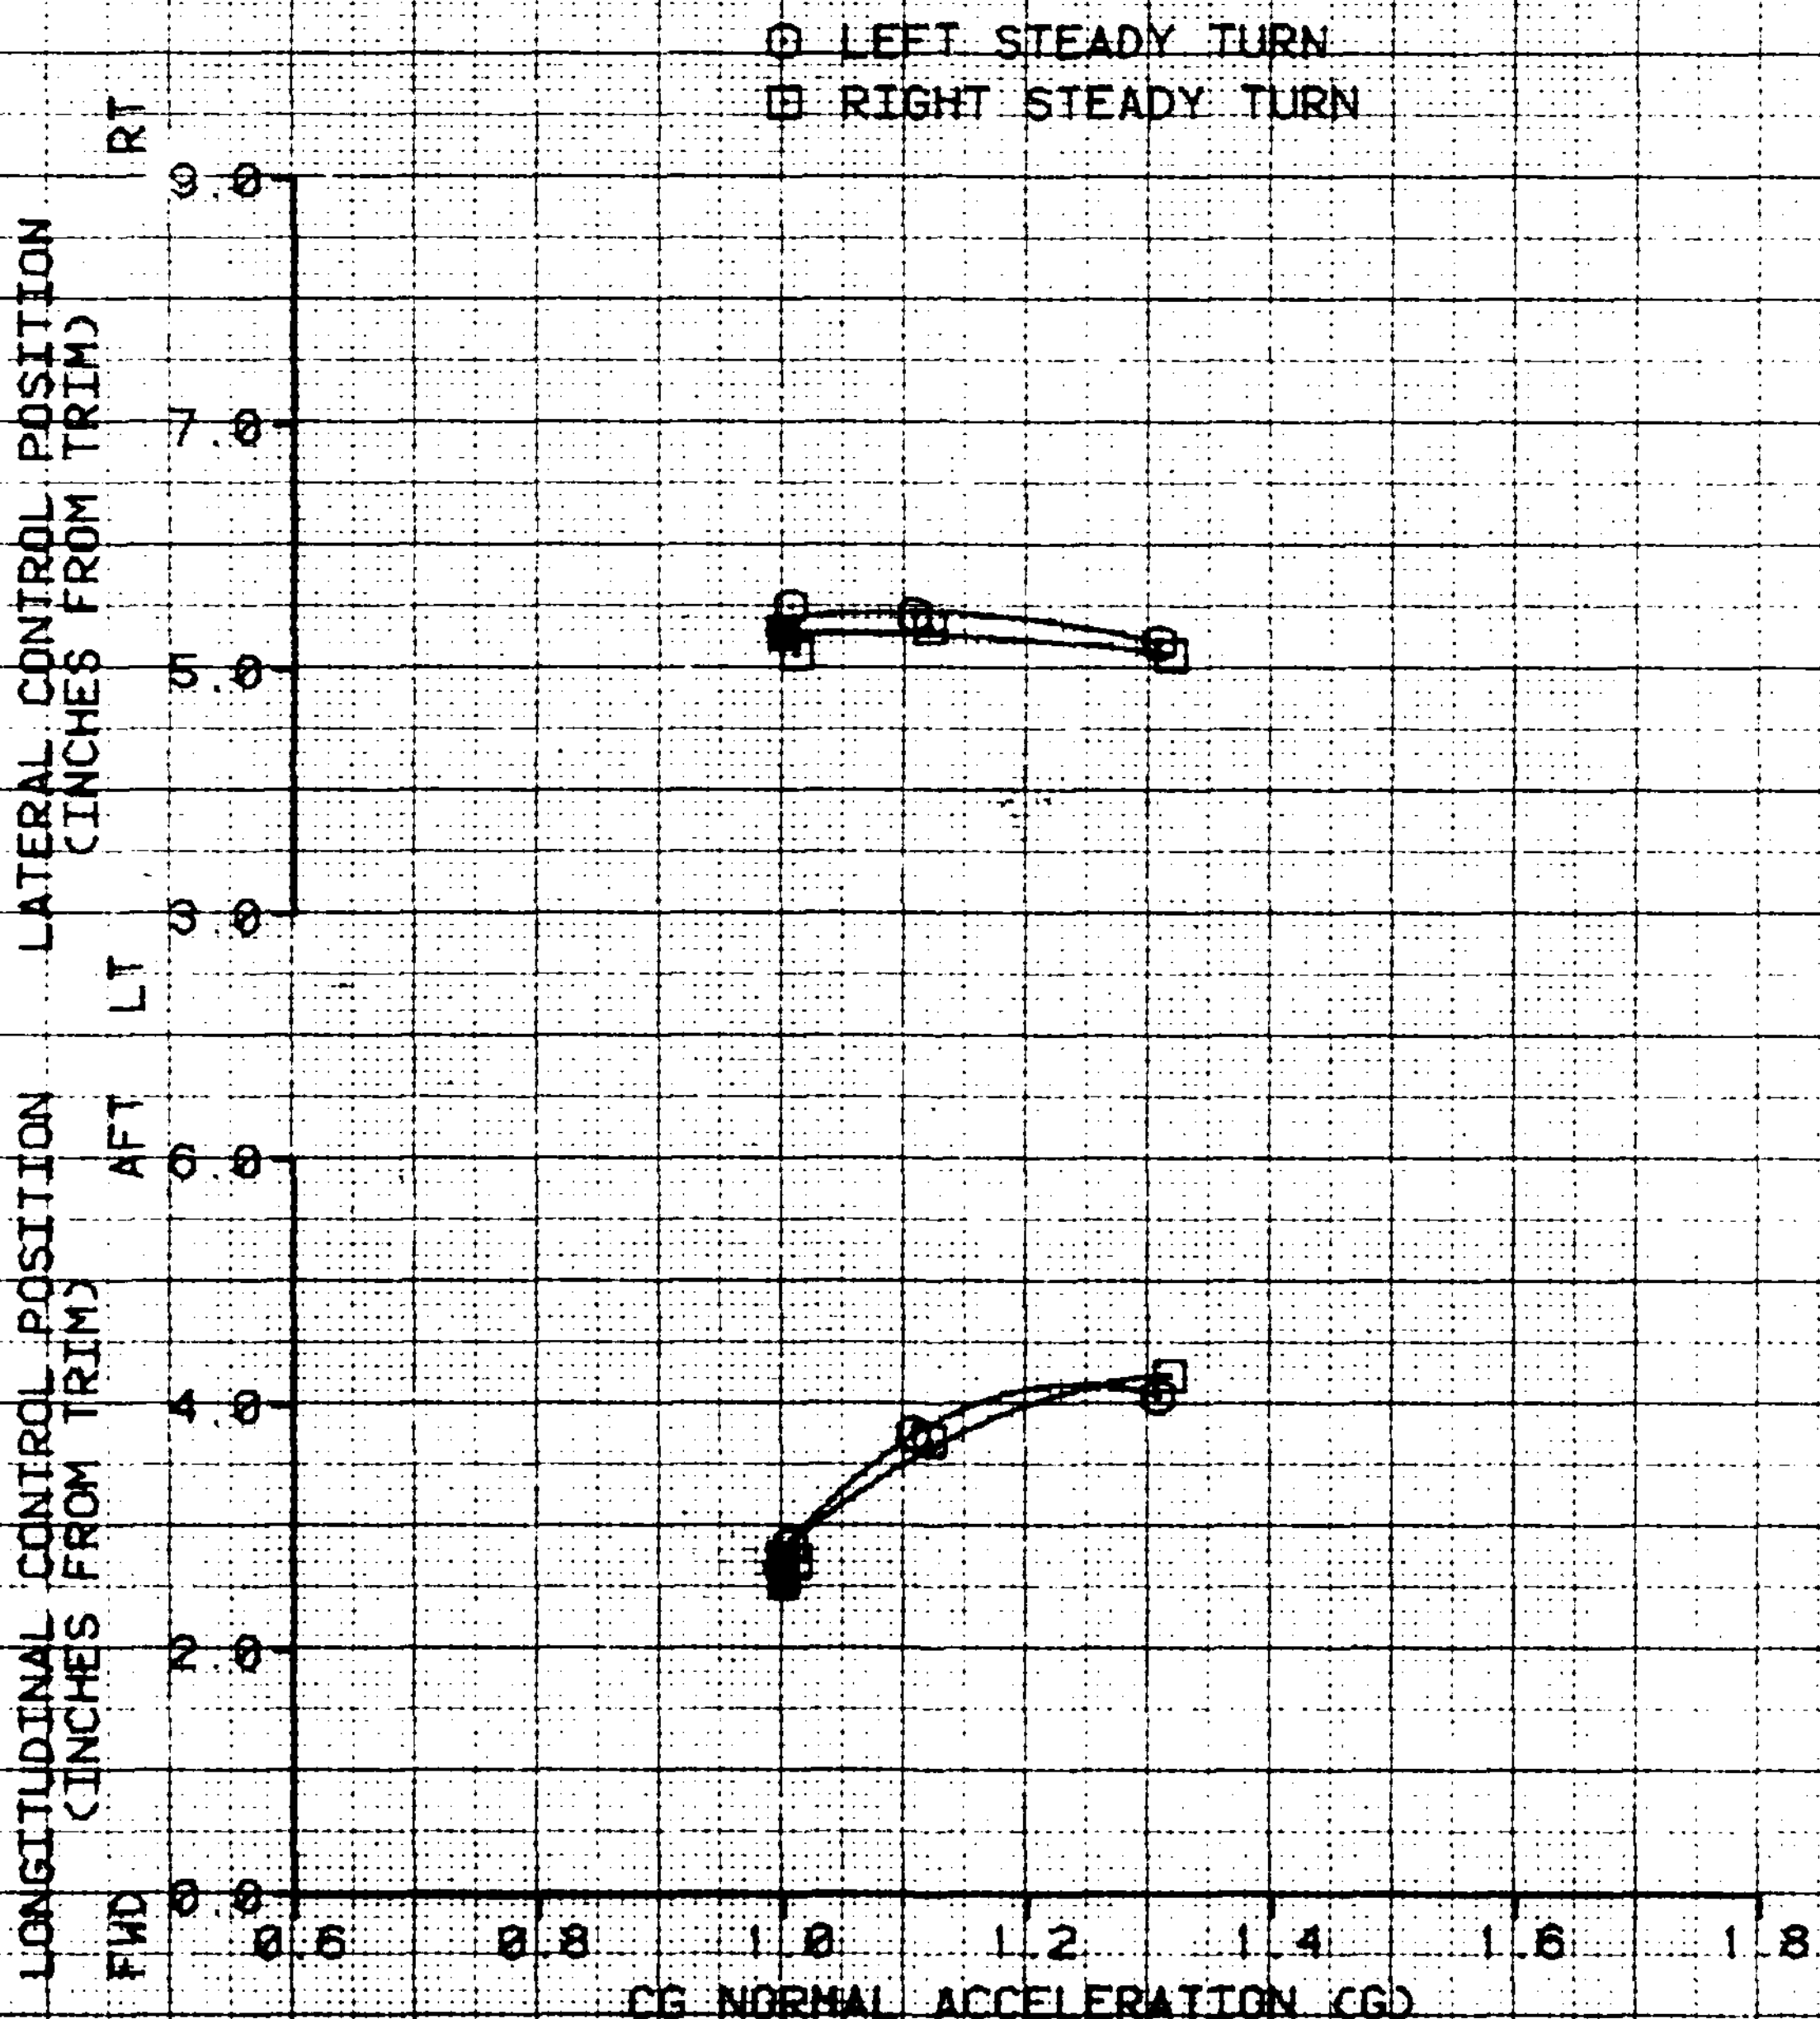
FIGURE 14
DYNAMIC STABILITY
JOH-58C USA S/N 69-15349

15. The short-term dynamic stability characteristics of the JOH-58C were evaluated at the test conditions shown in table 1. Data are presented in figures 14 through 17, appendix E. Gust

response characteristics were simulated by single-axis control pulse inputs of up to 1 inch for 0.5 seconds and by releases from steady-heading sideslips. The short-term dynamic stability characteristics observed in all axes were deadbeat. The aircraft was also flown in light to moderate turbulence with SAS ON and OFF. With SAS ON, the short-term rate damping combined with SAS attitude retention to improve the aircraft's gust response. The deadbeat lateral-directional response was a significant improvement over the easily excited lateral-directional oscillations of the standard OH-58C (ref 8, app A). With SAS OFF, the JOH-58C response was essentially unchanged from the standard OH-58C. The deadbeat gust response characteristics of the JOH-58C will significantly reduce pilot workload in turbulence. The short-term dynamic stability characteristics of the JOH-58C are satisfactory.

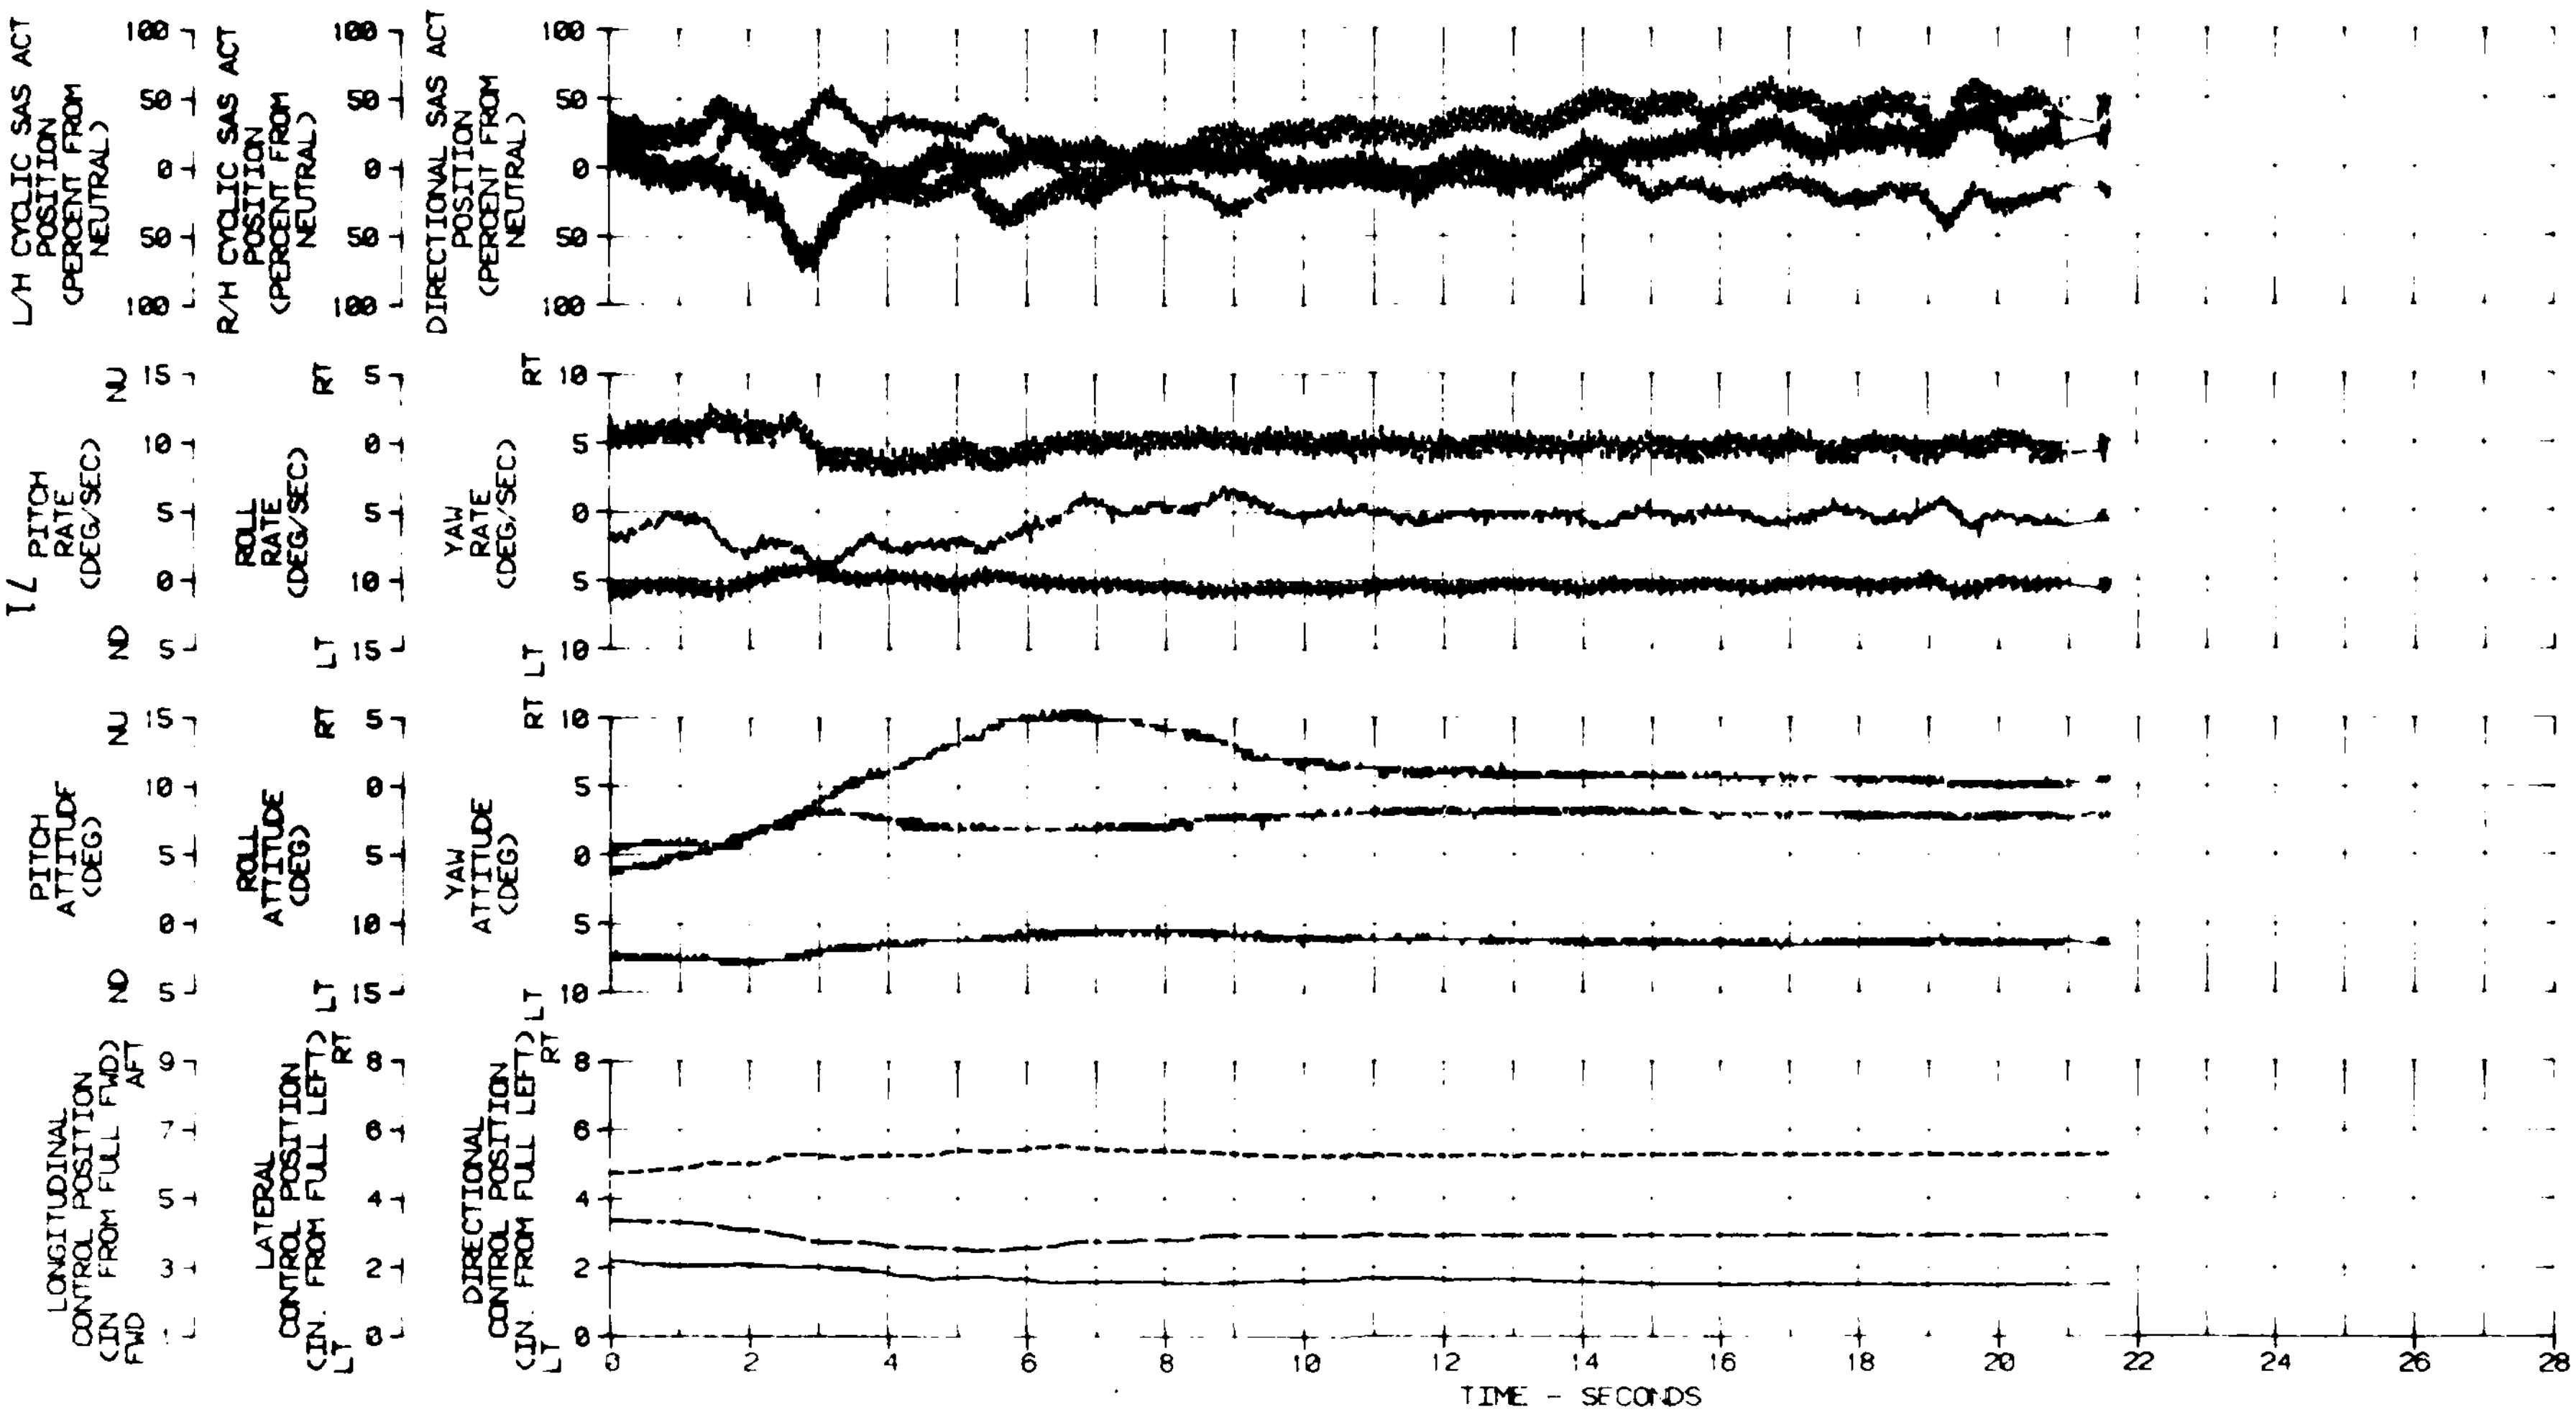
FIGURE 18
LONGITUDINAL LONG-TERM RESPONSE
JOH-58C USA S/N 70-15349

16. The longitudinal long-term response of the JOH-58C was evaluated at the conditions shown in table 1. No natural excitation of the long-term longitudinal response was noted. Artificial excitation produced the results presented in figure 18, appendix E. A 10-knot decrease in airspeed from the trim point at 80 KIAS resulted in a further decrease to 55 KIAS when controls were returned to trim. Displacement of the longitudinal control momentarily disabled the pitch attitude retention. When the control was returned to the trim position, the SAS attitude retention feature attempted to maintain the pitch attitude present at that time. This nose-up attitude resulted in a slower airspeed, but that attitude was then maintained by the SAS, eliminating any noticeable long-term oscillatory response. This was an improvement over the lightly-damped convergent oscillations of the standard OH-58C (ref 8, app A). The long-term longitudinal response was also evaluated with the aircraft in climbs of over 1000 feet per minute in an attempt to excite the divergent pitch oscillation noted in the operator's manual (ref 5) for aircraft equipped with infrared exhaust stacks (JOH-58C also incorporated these stacks). No pitch oscillation was noted with either natural or artificial excitation during climbs. The pitch attitude retention feature of the JOH-58C will reduce the pilot's workload in maintaining airspeed, freeing him to concentrate on his observation mission and/or providing a more stable platform for aircraft systems. The long-term longitudinal response of the JOH-58C is satisfactory.
